3 Dimensional View of  
Area where flashlight  
was located.  
(View is of aft looking forward)  
All materials are 6061-T6 Aluminum

Drawn by Tim Brooks  
on 01/27/2010  
Measurements taken from 2009 P2002 Sierra

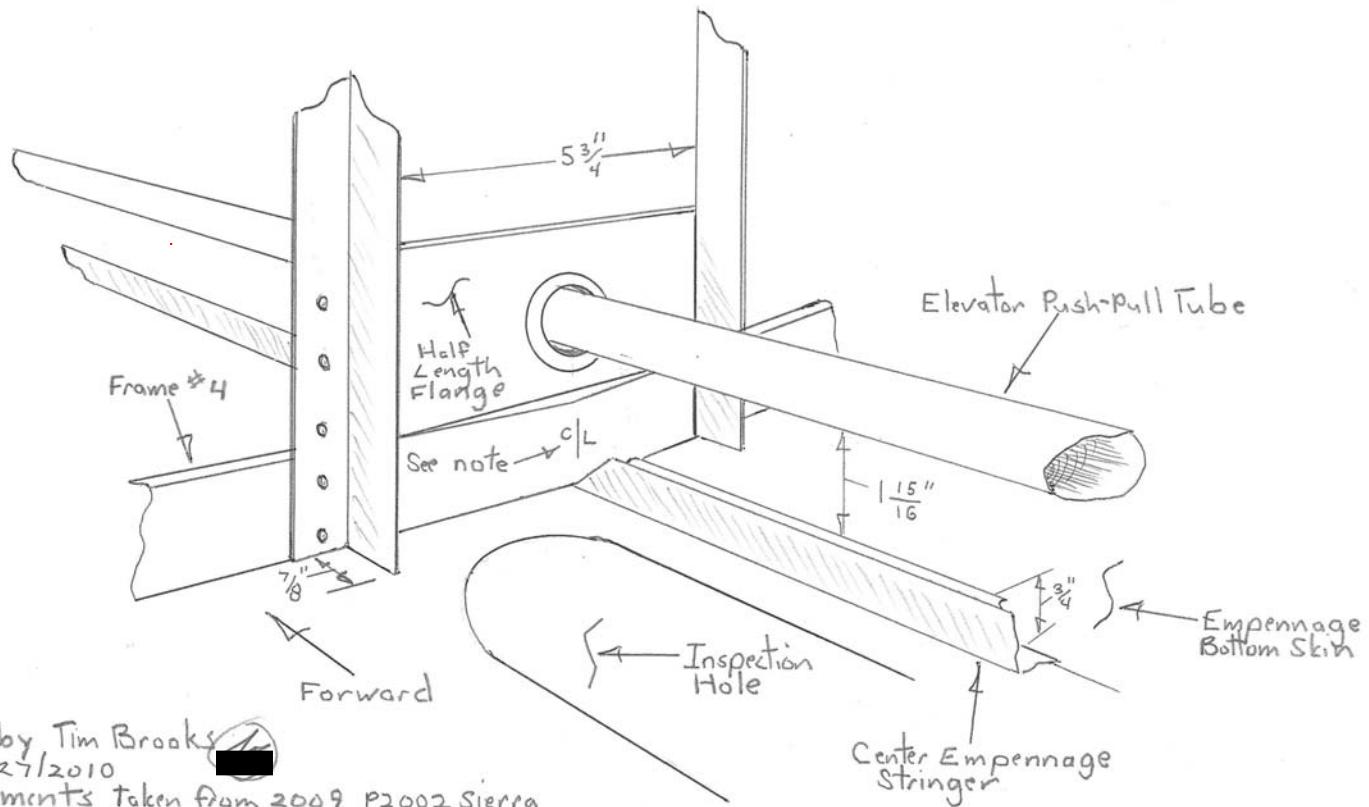
2 degree angle out from  
from aircraft belly center line
